Risk Assessment for Ionising Radiations Regulations 1999

Location of work	UHBristol Precinct
Date of commencement	Ongoing
Description of work	NHS
Source of Radiation	Naturally occurring radioactive materials Radon
Persons involved	Staff Patients / Relatives / Carers
Exposed Groups(critical groups)	Staff

Survey of Environmental Radon Gas Concentrations - 2016

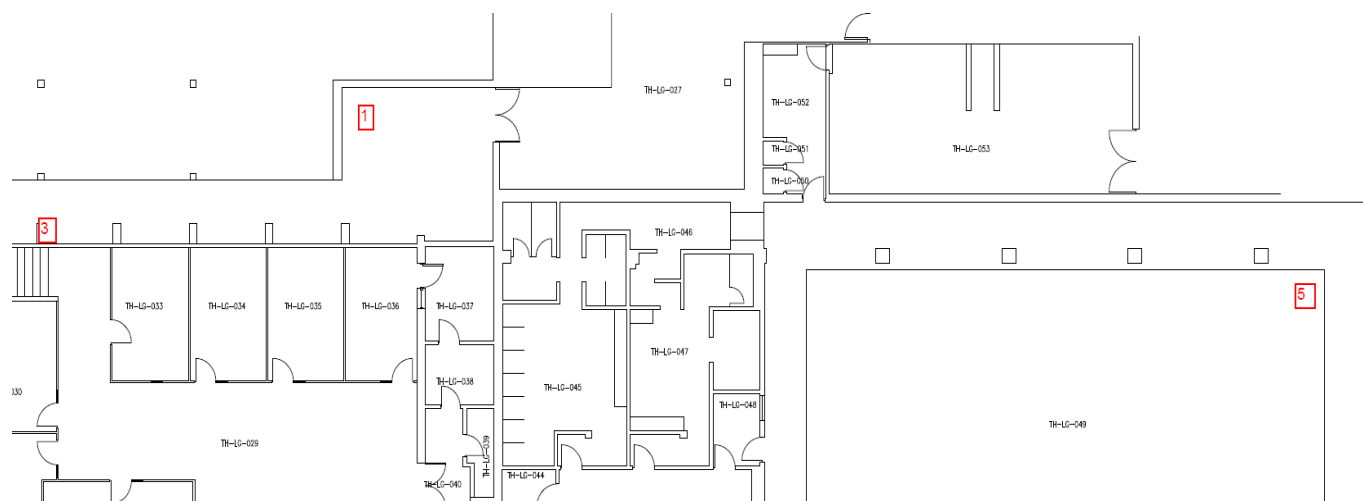
Trust HQ map 1

A total of 102 monitors were placed around the Trust in buildings below ground level. Monitor positions are marked on plans given in the appendix. Details results are given in tables, below.
